What's Wrong with This Picture ?

Exit Corridor: Fire and Casualty Safety

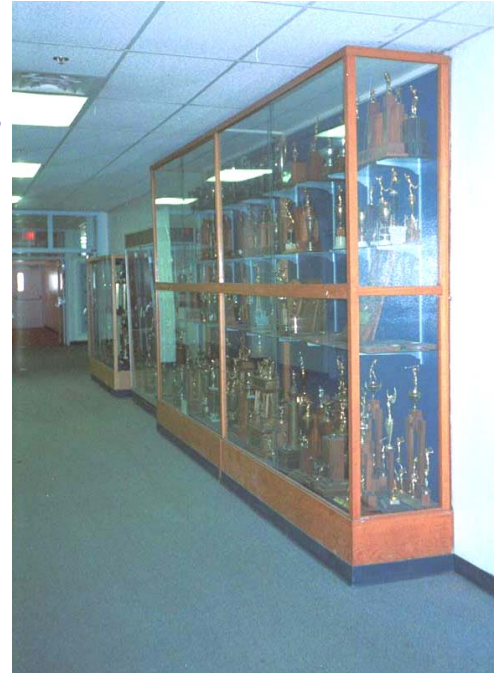
Note the potential hazards this large shop-made trophy case in the foreground presents. This wood and glass case is about sixteen feet long, two feet deep, and floor to ceiling high. There are also two or three other display cases further down the corridor.

The corridor was designed just wide enough to meet minimum code requirements for a safe, rapid exit. Adding trophy and display cases or lockers or other furniture reduces this minimum width and presents physical obstructions in an emergency evacuation. Note also how placement of cases obstructs sightlines to exit doors beyond and classroom doors between the cases. Remember any potential hazards presented by construction materials such as large sections of glass near the floor as well as combustible materials. Safety or tempered glass must be placed in certain areas to offset the casualty hazards of broken glass.

Keep in mind that exit path maps, “*You are Here*” signs, are required in certain locations to show occupants correct exit paths in an emergency. These signs must be readily visible and direct people through, clear and protected means of egress.
