What's Wrong with This Picture ? Casualty Safety

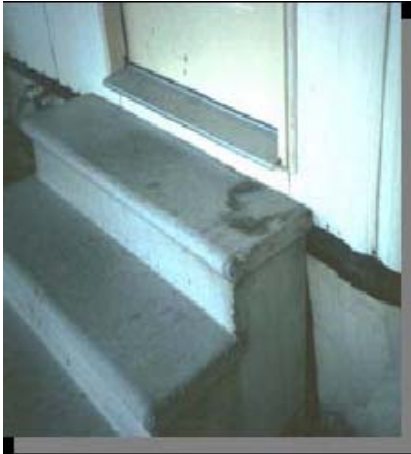
Entrance doors at raised relocatable classrooms present unique problems. Fall from a raised floor is the primary concern and having existing prefabricated steps may present immediate problems. Look at the picture and you can see a number of dangerous conditions. A required landing at the top of the steps or ramp is not provided. How are you supposed to open the door from inside or outside safely? Where are handrails and guardrails? Notice the tripping hazards at the door sill where the top step is not level with the floor and the threshold hangs over the top of the steps.

Also notice another existing hazard created by a raised floor. The open space under the relocatable creates a crawl space intended for access for maintenance and structural purposes only. A metal skirt has been added to seal off the open space but it is not firmly attached and the sharp edge of the top of the skirt is exposed. Unfortunately children playing in the area, workers, or even intruders who have no business being there, could hurt themselves and the district could be considered at fault.

These are all violations that must be corrected as soon as possible and cited in annual safety inspections.
